What's the Risk?

Protect Tanks from Vehicular Impact

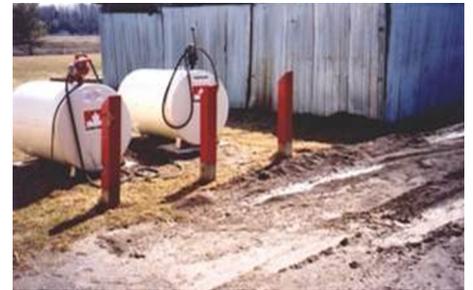
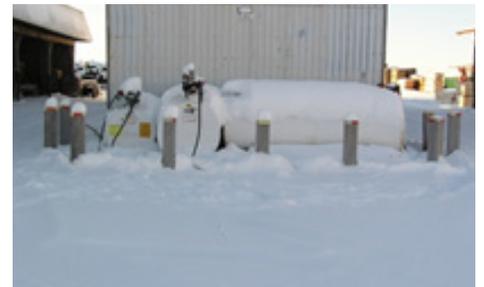
Installation of bollards around tanks provides the protection required to prevent vehicular impact. A bollard is a short post designed to identify or segment a location, guide traffic, or protect sensitive areas. Bollards are used in many applications, including road or boundary markings, managing vehicle traffic and protecting buildings and landscapes. They also provide a very effective visual barrier and offer significant impact protection where required.

- (a) Be spaced not more than 54 inches (1350 mm) apart.
- (b) Be buried not less than 36 inches (900 mm) below grade.
- (c) Extend at least 30 inches (750 mm) above grade; and
- (d) Be one of the following:
 - i. 4 inch (100 mm) capped steel pipe.
 - ii. 4 inch (100 mm) tubing filled with concrete.
 - iii. 8 inch (200 mm) pressure-treated wood, either square or round, or
 - iv. 6 inch (150 mm) minimum dimension reinforced concrete
